LAUREL RUN DAM

NDI ID No. PA-00380  
DER ID No. 35-6

PHASE I INSPECTION REPORT

(6) NATIONAL DAM INSPECTION PROGRAM.

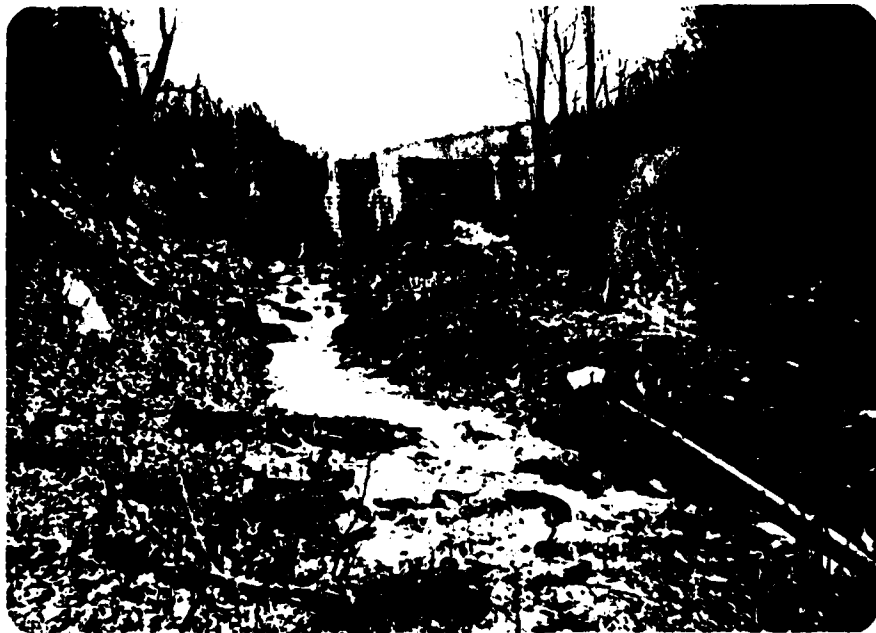
B. View Looking Upstream
